Office of Compliance

Report on Americans with Disabilities Act Inspections Relating to Public Services and Accommodations

July 2007

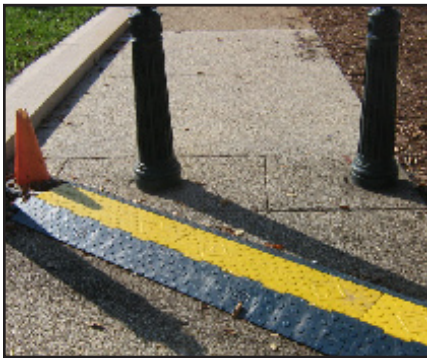
Figure 1: Non-compliant temporary sidewalk ramp

complex. A constituent using a motorized wheelchair was injured while crossing a temporary sidewalk ramp that was too steep. The AOC replaced the ramp with an ADA-compliant ramp, and is now working toward a permanent solution. This charge is pending closure.

In 2006 an ADA public access charge was filed with the OOC following an injury to a constituent caused by the steep slope of a temporary ramp on the sidewalk along Independence Avenue. The constituent was visiting Capitol Hill and injured his head when his motorized wheelchair fell over backwards as he was attempting to cross the temporary ramp. The AOC fixed the problem after the OOC raised the issue. The AOC should be mindful about using non-compliant temporary ramps for any project in an area open to the public.

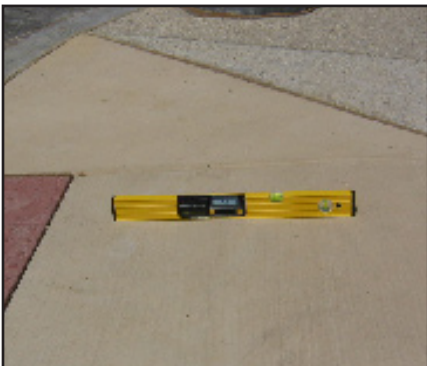
Figure 2: Non-compliant newly installed sidewalk curb cut

OOC inspectors have measured numerous sidewalk curb cuts throughout the Capitol Hill grounds that are too steep to be considered accessible.³ Some of the non-compliant curb cuts were recently installed.⁴ The OOC recommends that the AOC survey all of the Capitol complex’s sidewalks and grounds to ascertain which curb cuts are not in compliance with the ADA, and immediately fix those that are non-compliant. Accessible sidewalks are a fundamental public access issue for any constituent who is in a wheelchair.⁵

³ Curb ramps must have 8.3% rise or less and must otherwise comply with 28 C.F.R. Pt. 36, App A §4.7.

⁴ New curb cuts on existing sidewalk are alterations, and therefore must strictly meet the requirements of the ADA regulations. 28 C.F.R. §36.402(b)(2).
