Biennial Report¹ on Occupational Safety and Health Inspections

Conducted in the legislative branch during the 109th Congress pursuant to the Congressional Accountability Act of 1995

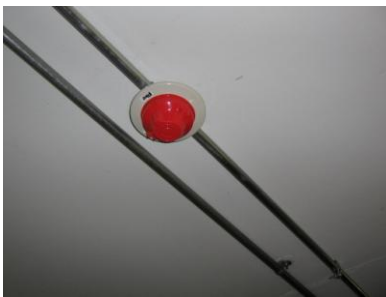
While some progress has been made in complying with the OSHA and NFPA standards, the inspection team found 86 instances of obstruction and failure to maintain the required eighteen inches of separation between the sprinkler heads and obstructions during the 108th Inspections; and, over 300 instances during the 109th Inspections.

Picture 1 Capped fire sprinkler

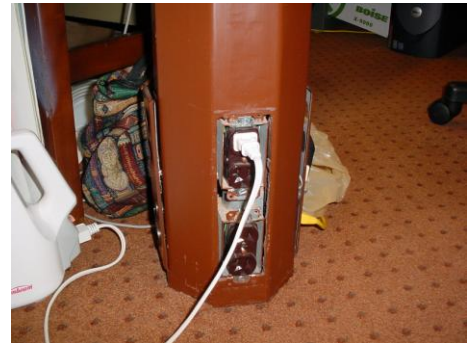
employee reach. A majority of these hazards qualified as RAC 2 in severity requiring prompt correction. Several qualified for RAC 1 in severity requiring immediate attention. Hazards of this type were specifically noted in the 1998 and 2002 Reports. 1998 Report, p. 21; 2002 Report, pp. 39-40. Many remain unabated.

Picture 2 Faceplate missing from outlets

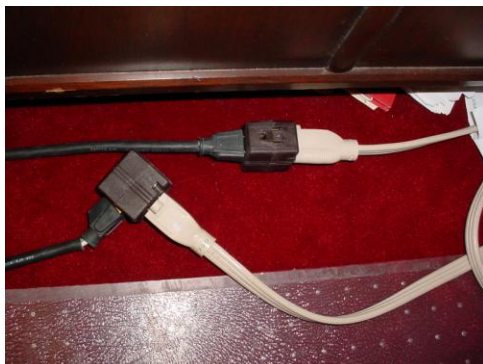
Picture 3 Extension Cords and Cube Tabs in Use

The 109th inspection continued to reveal numerous locations using non-permanent wiring in lieu of available outlets. Over 2,300 locations were found with extension cords used as permanent wiring. An additional 2,400 locations had "daisy chains" wherein power strips or surge protectors were linked to extend their reach or increase capacity. Both of these conditions violate the National Electrical Code and OSHA requirements. These standards establish that extension cords may not be used as permanent wiring and their use may not

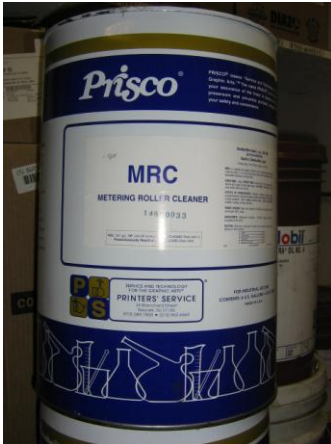
Picture 4 Product containing Methylene Chloride

Methylene chloride is a volatile chemical that has been used as a stripping agent and industrial lubricant. Since 1998, its use has been strictly regulated by OSHA because of its carcinogenic nature. Methylene chloride is known to cause respiratory distress, depress the nervous and cardiovascular systems, damage the liver and kidneys, and cause eye irritation. For this reason, the use of and exposure to methylene chloride are subject to strict monitoring and exposure control requirements. The OOC inspection team discovered methylene chloride in use, or stored in legislative branch facilities, without the proper hazard communication and chemical use program, and monitoring in place despite prior reports warning against this hazard.

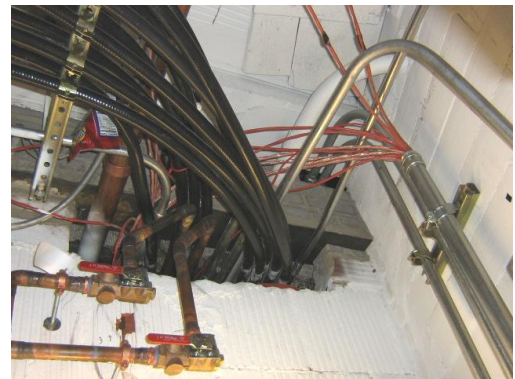
Picture 5 Penetration in a fire wall

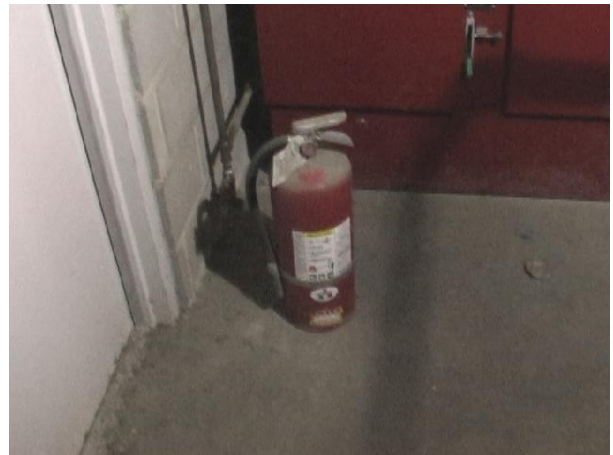
Fire extinguishers: The National Fire Code requires that portable fire extinguishers be mounted on walls or stored in an accessible case. Fifty-six fire extinguishers were inaccessible and another nineteen were not properly mounted or secured. Additionally, portable fire extinguishers must be inspected monthly for damage and charge, and inspected yearly by a company certified to conduct inspections and repairs by the manufacturer. These monthly and annual inspections are usually documented using inspection tags attached to each fire extinguisher. The OGC inspection team found over 130 fire extinguishers to be beyond their monthly inspection date. Fire extinguishers that are not checked on a regularly scheduled basis may lose their charge and may not work as intended in an emergency situation.

Picture 6 Unsecure fire extinguisher
