BENIGNAVAL REPORT

Accessibility Report for the 117th Congress

on Americans
with Disabilities
Act Public
Services and
Accommodations
Inspections

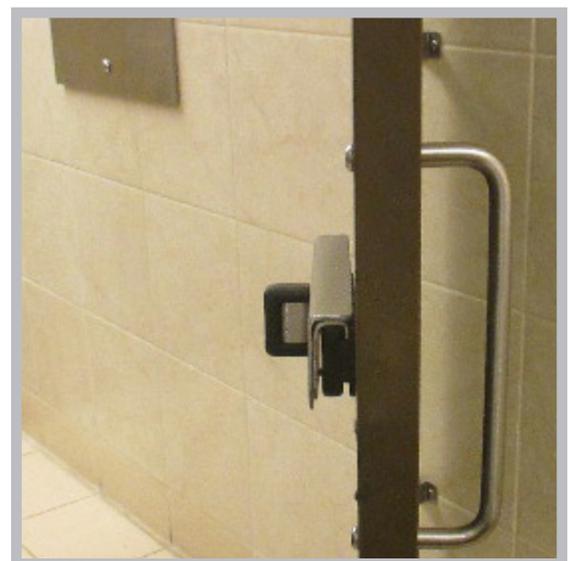
This image shows a bathroom stall door with a door pull provided on only one side of the door.

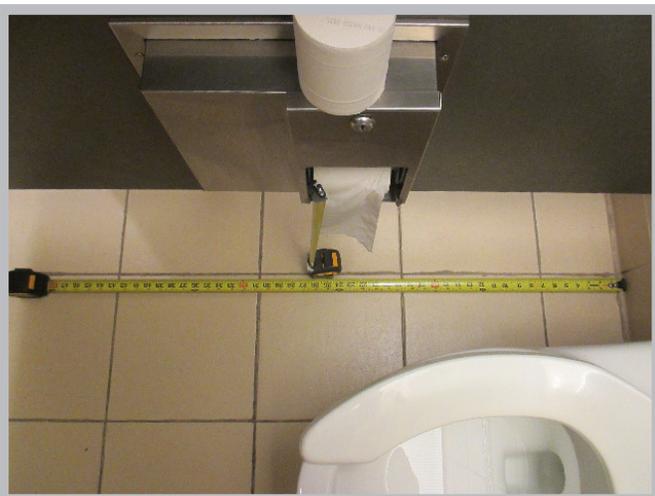
A toilet paper dispenser's centerline is located behind the front of the toilet.

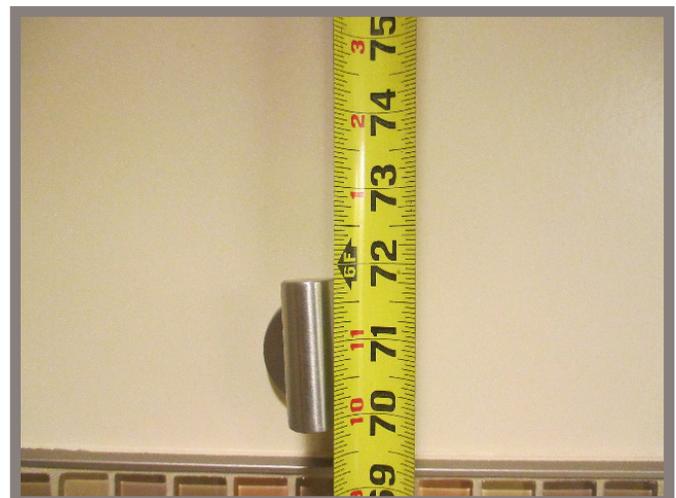
A coat hook is mounted at 72 inches high on a bathroom wall.

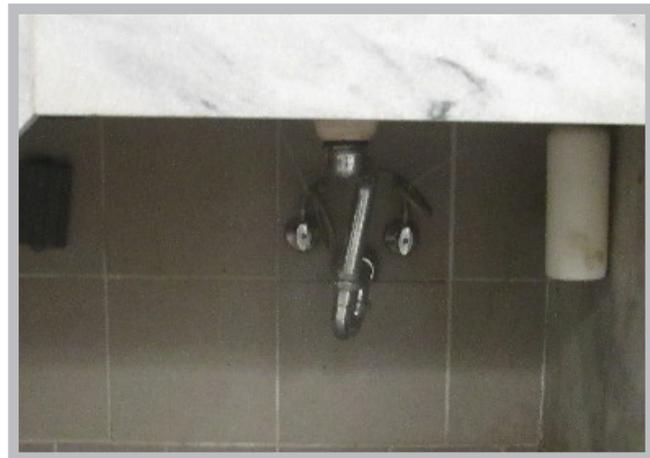
These include barriers that could make using the bathroom a challenging experience for people with a variety of disabilities. For instance, pipes below a sink that are not covered or insulated can pose a hazard to mobility device users when positioning themselves at a sink. A sign for the bathroom that protrudes from the wall and is positioned too low can pose a hazard for someone who is blind or has low vision. A coat hook mounted too high on a stall door can pose a barrier for mobility device users, people of short stature, and people whose disabilities limit arm movement.

Pipes below a bathroom sink are not insulated or covered.

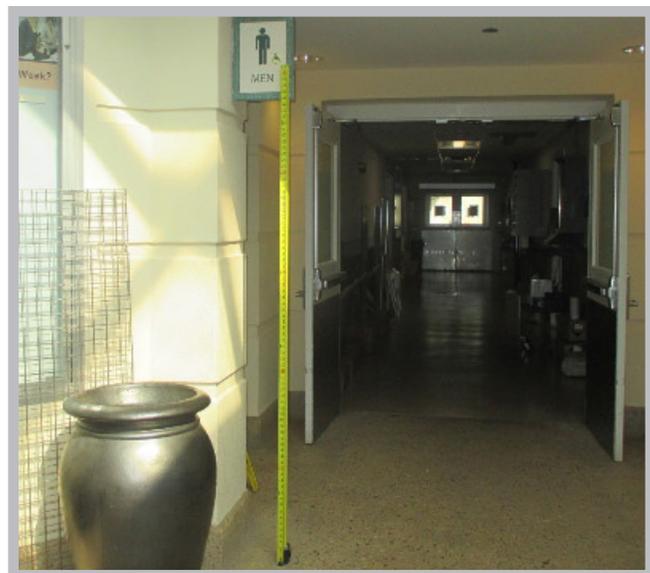
A bathroom sign protrudes from a wall 77 inches above the floor.

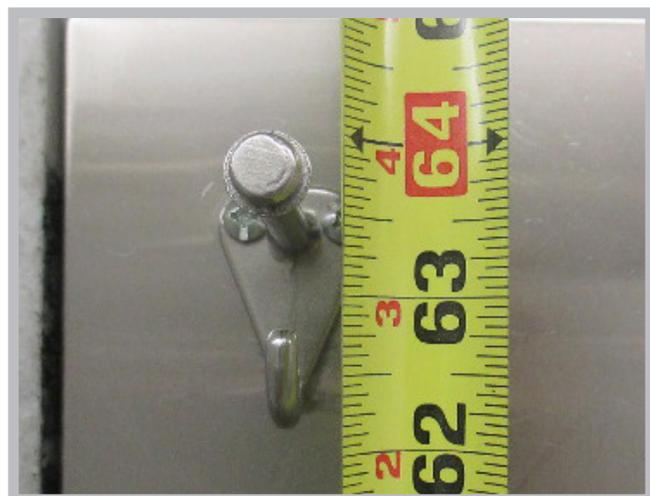
A coat hook is mounted at 63.75 inches high on a bathroom stall door.

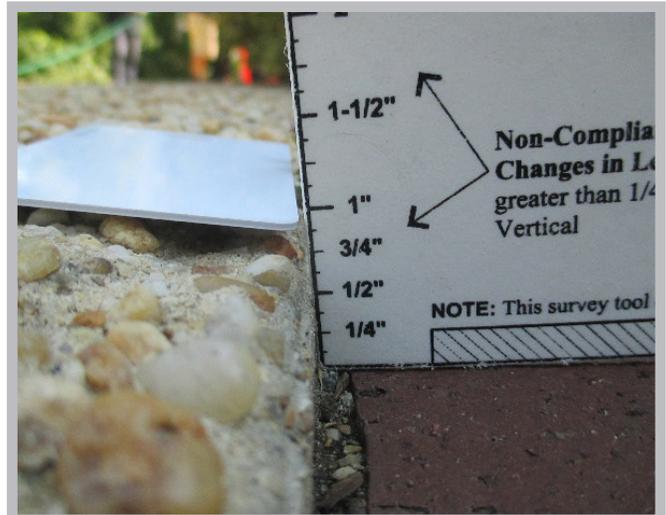
A vertical transition measures 0.875 inches high.

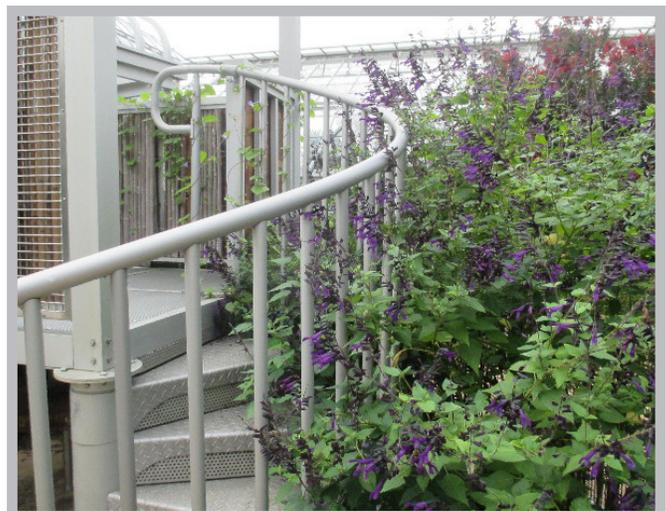
Handrails at a spiral staircase are obstructed by overgrown plants.

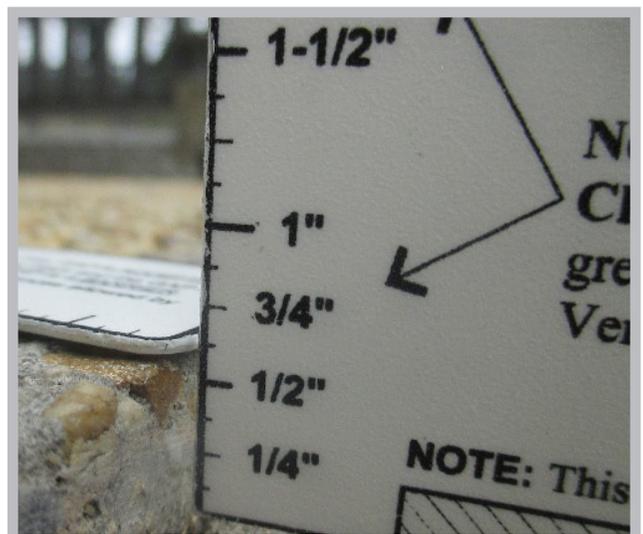
A vertical transition on a sidewalk measures 0.625 inches high.

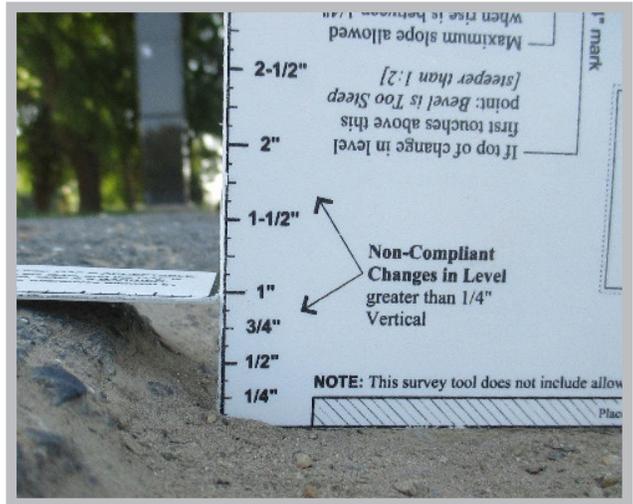
A vertical transition on a sidewalk measures 1 inch high.

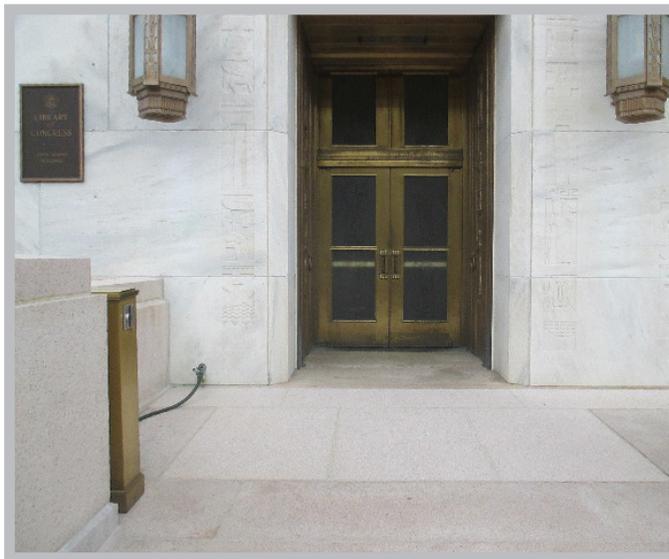
The ground is excessively sloped at the automatic door control, which could make it challenging for mobility device users to press the button to open the door.

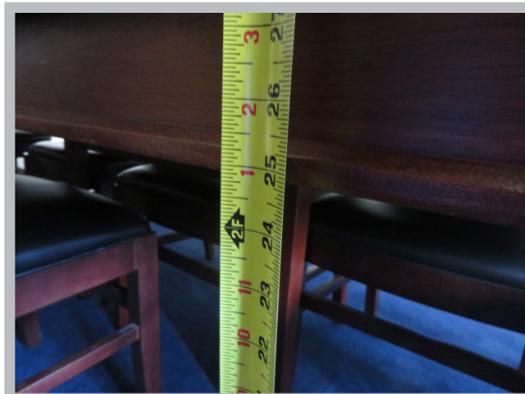
A table's knee clearance measures 25 inches high.

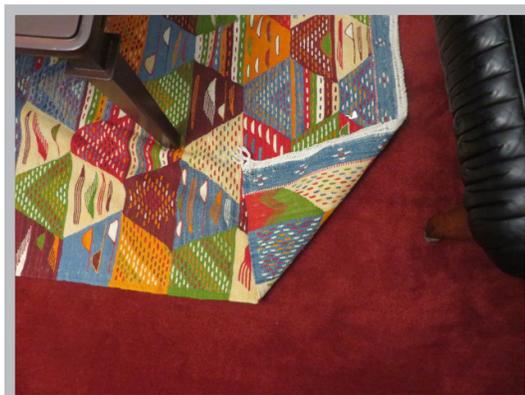
The edge of a rug folds easily and can cause tripping.

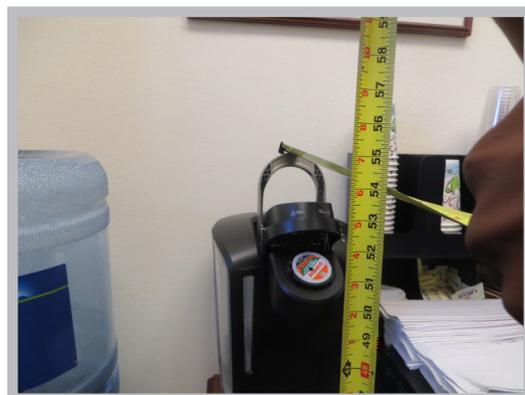
A coffee maker measures 54 inches high.

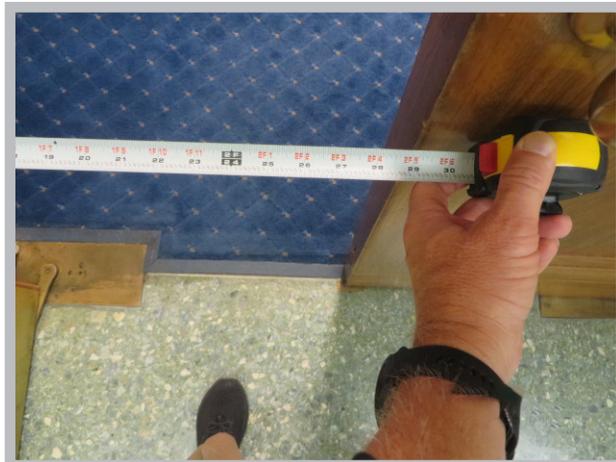
These barriers pertained to doors with inadequate clear width for a wheelchair user, or other mobility device user, to pass through. At a double-leaf door, at least one active leaf must provide 32 inches of clear width. While we note these particular barriers in our database, they are considered resolved as the occupants of the rooms clarified the doors either remain open during business hours, a door attendant is present during events, or the room is not for public access.

A door's clear width measures 29 inches.

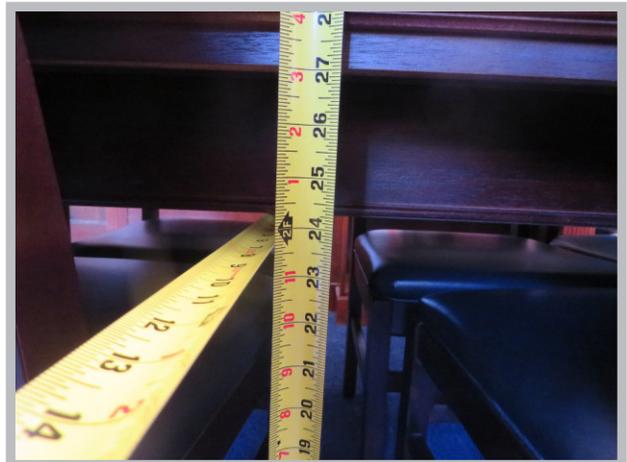
Meeting tables without enough knee and/or toe clearance for wheelchair users make up a significant portion of the barriers identified in Member offices each Congress. The CAO recognizes this and continues to explore alternative possible ADA-compliant table options.

A table's knee clearance measures 23.5 inches high.
