Office of Compliance

fast facts

January 2008

Missing Ceiling Tiles

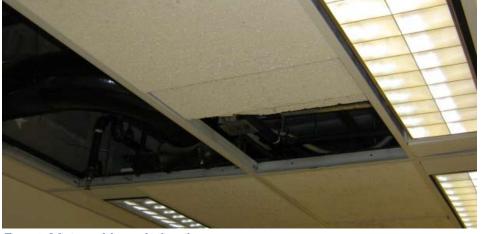
Figure 1: Missing and damaged ceiling tiles

Ceiling tile breakage, displacement, or removal often occurs as a result of mechanical system repair or maintenance. Because fires are unpredictable, intact tiles must be returned to their intended positions as soon as possible following such repairs. Office occupants also often move aside or remove ceiling tiles, typically to improve personal comfort by altering local air currents. The danger this creates impacts not only the person who moves the tile, but also endangers all building occupants. Moreover, older ceiling tiles may also contain asbestos, so disturbing them can cause yet another health hazard (See the Office of Compliance's "Asbestos: Do Not Disturb" Fast Facts).

Minimizing the number of unnecessary ceiling openings will make a building safer for all occupants. Employees should report any unnecessary ceiling openings to appropriate maintenance authorities.
