# fast facts

## ***Exposed, Energized Wiring and Electrical Components***

***February 2010***

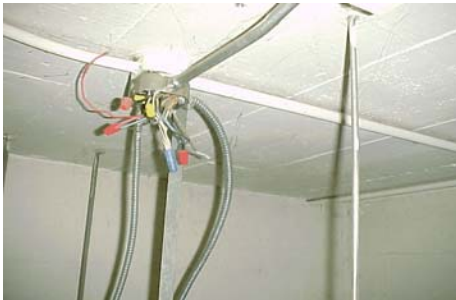
Figure 1: Potentially hazardous electrical junction box without cover

Junction boxes without covers are the most common places to find exposed and hazardous wires. Electricians use junction boxes to connect new installations or extend existing installations. When energized junction boxes are uncovered, the wiring is vulnerable to damage and accidental contact. If easily combustible materials, such as paper or cardboard,

are stored near unprotected energized wiring, a spark or electrical arc could easily start a fire. Figures 1 and 2 are examples of junction boxes with exposed wiring.

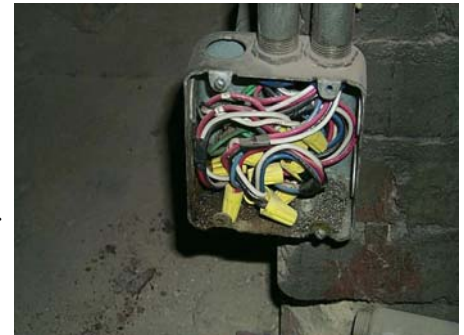
Figure 2: Potentially hazardous wall switch or outlet box without cover

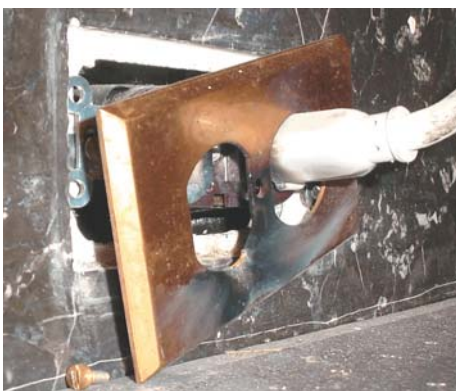
Figure 3: Potentially hazardous burnt outlet with displaced cover

Electrical outlets and light switches with broken, displaced, or missing covers may also expose wiring which endangers any employee plugging in an appliance or turning on a light. Both OSHA and NFPA require that outlets and switches remain covered. Figure 3 shows an outlet with a displaced cover and a burn mark, and Figure 4 shows a completely uncovered outlet next to a light switch. This is an especially dangerous hazard for anyone trying to find the switch in the dark.

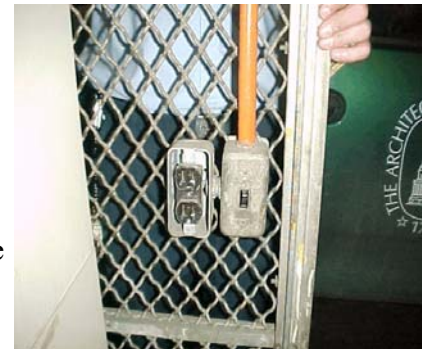
Figure 4: Potentially hazardous outlet with no cover next to switch

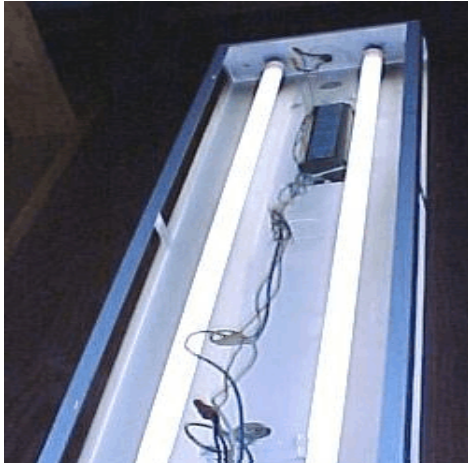
Figure 5: Missing cover on fluorescent light fixture exposes wiring

Electrical hazards may also be found in light fixtures. Uncovered fluorescent lights, incandescent light fixtures without bulbs, or light fixtures hanging by wiring are all dangerous. Fluorescent lights have energized wiring, starters, and ballasts under their protective covers. If the light's cover is not properly replaced, these hazards are exposed. When an incandescent bulb is removed and not replaced, the open socket presents a hazard if it remains energized; and therefore, it is best to leave the burnt bulb in the socket to cover the electrical contact until the bulb is replaced. The fluorescent light fixture without a cover in Figure 5 shows exposed wiring. Figure 6 shows an improperly mounted light fixture with an open socket and exposed wiring.

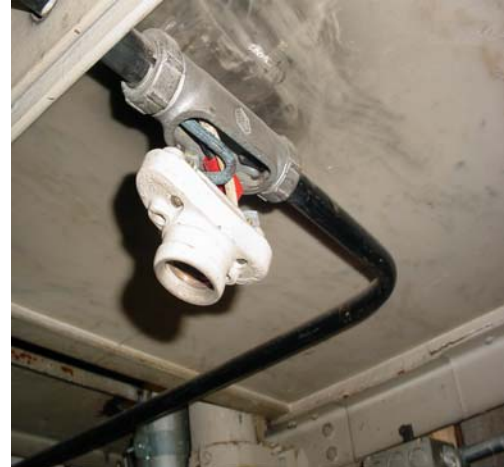
Figure 6: Light fixture not properly secured to mounting with open socket and exposed wiring

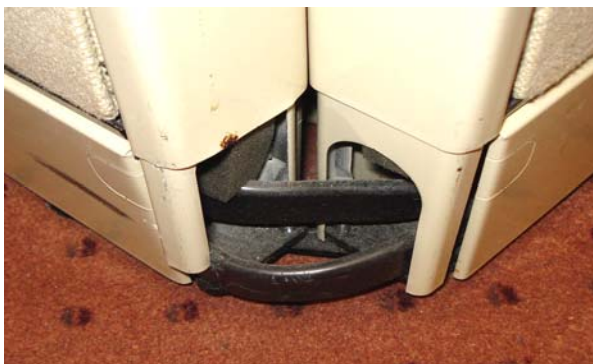
Figure 7: Exposed power wiring at corner unprotected from impact and damage

Modular furniture provides electrical power and must protect occupants from shock hazards. Because the furniture has live electrical wiring running through it, it is important to enclose and protect the wiring within each module. Corner and baseboard wiring covers are needed to prevent accidental shock hazard contact and damage to wiring. Figures 7 and 8 are examples of unprotected wiring in modular furniture that people could contact accidentally.

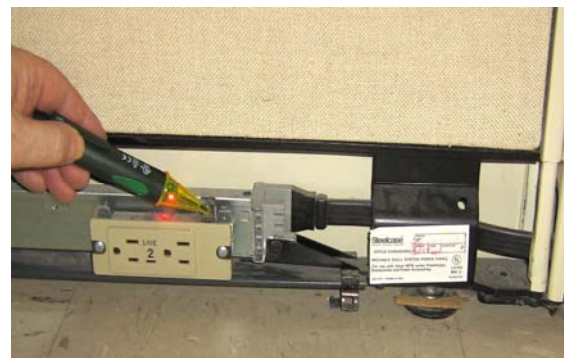
Figure 8: Exposed baseboard electrical supply outlet and service without its cover
