Biennial Report¹ on Occupational Safety and Health Inspections

Conducted in the legislative branch during the 109th Congress pursuant to the Congressional Accountability Act of 1995

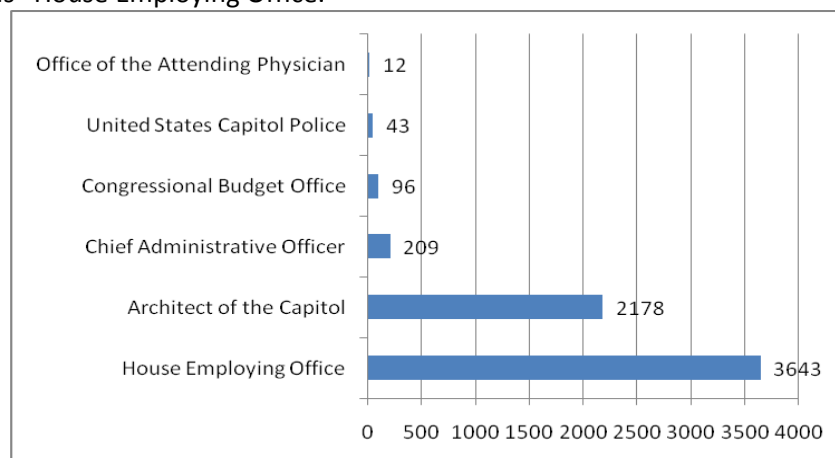
Figure 26 Hazards Cited in the House Jurisdiction by Responsible Office

Many offices occupy space within the House Office Buildings including Members, Committees, the Office of the Clerk, the Office of the Inspector General, the House Sergeant at Arms, the Office of Legislative Counsel, the Office of Law Revision Counsel, Leadership offices, the Office of the Chief Administrative Officer, and the Architect of the Capitol. For purposes of responding to the OOC’s safety and health investigation findings, the Office of House Employment Counsel (OHEC) represents a large number, but not all, of the House employing offices, and receives and responds to the OOC’s inspection findings on their behalf. Accordingly, the offices represented by OHEC, namely the Members, Committees, House Leadership, the Clerk, the House Sergeant at Arms, the General Counsel, the Law Revision Counsel, and the Legislative Counsel, are collectively referred to in the following chart as “House Employing Office.”

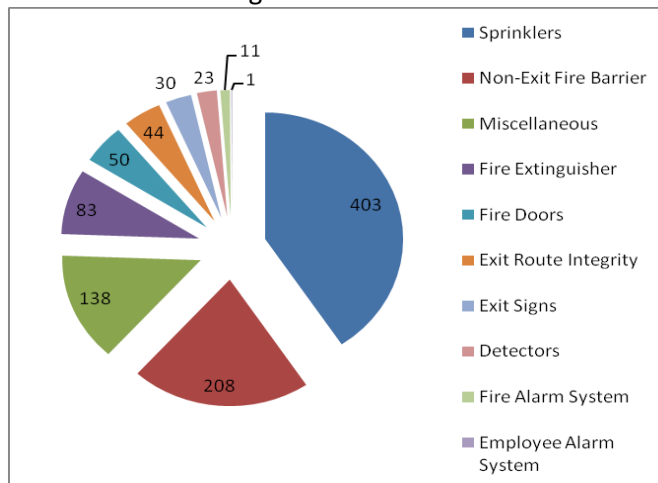
Figure 28 Fire Safety Hazards Cited in the House Jurisdiction

Deficiencies involving sprinkler systems were the most common fire safety hazard. The inspection team noted at least 160 locations where high storage of materials either blocked water distribution from the sprinkler heads, or were stacked above the sprinkler heads, thereby impeding their ability to extinguish fires. Storage must be kept at least eighteen inches below the plane of the sprinkler heads to ensure proper water dispersion.

The National Fire Code requires that portable fire extinguishers must be inspected monthly for damage and charge, and inspected yearly by a company certified to conduct inspections and repairs by the manufacturer. The inspection team found fifty-eight fire extinguishers to be beyond their monthly inspection date. Fire extinguishers that are not checked on a regularly scheduled basis may lose their charge and may not work as intended in an emergency situation.

The inspection team identified seventeen locations within the House jurisdiction that lacked an exit sign where one was needed. In three instances, exit signs were present but lacked or had incorrect directional markers. Four exit routes were found to lack adequate emergency lighting during the survey, either due to the failure to install proper emergency lighting or failure to maintain charged back-up batteries or functional light bulbs.

The OGC has issued several citations in 2000 addressing the very serious RAC 1 hazards of open unprotected exit stairways and exit routes from the upper floors in House buildings. They remain unabated. It is well known that most fire related fatalities occur because of smoke and toxic gas inhalation by the victims. Such open exit stairways provide a readymade chimney to convey these products of combustion from a smokey or self-sustaining fire to the higher floor levels in the building and have the potential to prevent employees on these levels from safely evacuating the building during a serious fire event.

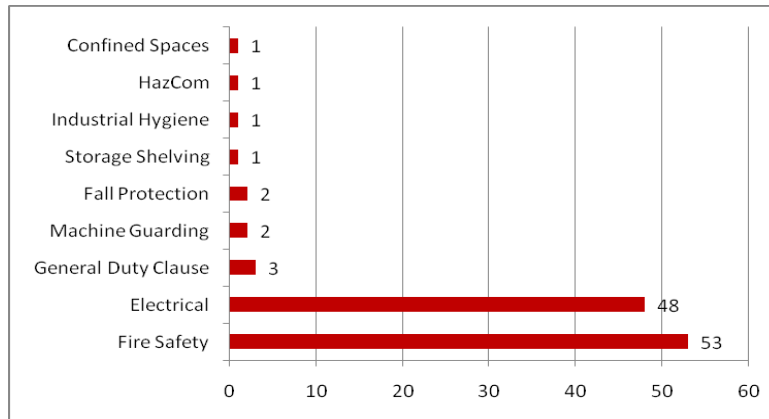
Figure 32 Types of Hazards Cited in the USCP Jurisdiction

The most common findings in the USCP occupied facilities were fire safety or electrical issues. The other findings included General Duty clause findings (discussed below), slip, trip, and fall hazards, unsecured storage shelving, products containing methylene chloride (a regulated carcinogenic chemical) without compliance with OSHA’s Methylene Chloride Standard and Hazard Communication Standard and several confined spaces that were not posted with proper hazard signage. Many of the findings were abated within 24-hours of the inspection. As of August 1, 2007, ninety-one of the 112 findings (81.3% of the total findings) in the USCP-occupied buildings were reported as abated. The distributions of findings are show and discussed below:

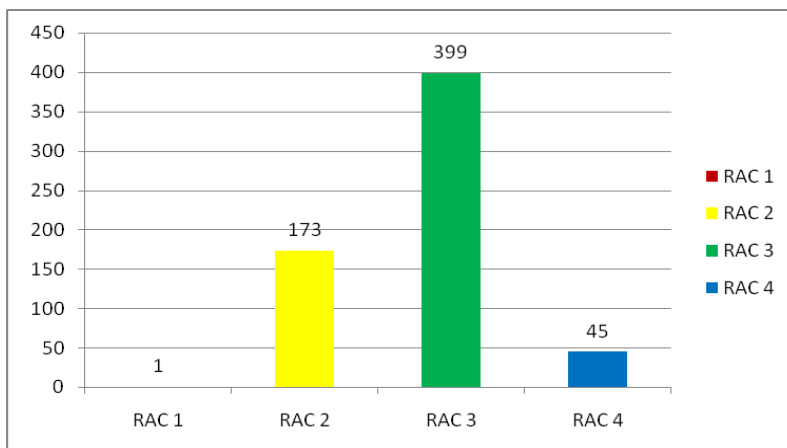
Figure 34 Distribution of RACs in the GAO Building

The OOC has fully inspected the GAO in both the 108th and 109th Congress. The OOC has worked closely with the GAO in order to abate hazards in a timely manner and upon request from the OOC, the GAO reported that its abatement rate would exceed 95% by the end of 2007. The GAO is the sole responsible office in the building, though it does receive limited support and services from the executive branch. The OOC identified 618 hazards in the GAO buildings. The charts below express the distribution of RACs in the GAO building and the most common types of hazards identified.

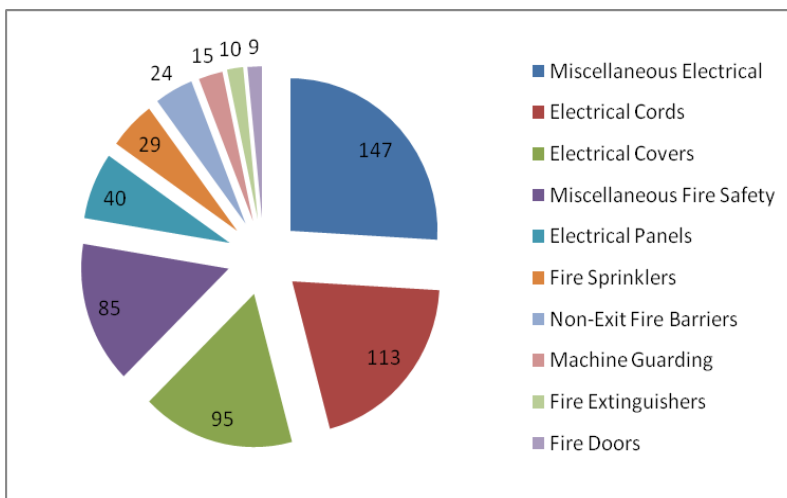
Figure 35 Common Types of Hazards Identified in the GAO Building

The chart above expresses 567 of the 618 hazards identified in the building. The distribution of findings are very similar to the other legislative branch jurisdictions in that general electrical hazards are the most common hazards identified. The use of non-permanent cords in lieu of permanent wiring, daisy chains, and unapproved portable space heaters were all common findings in the GAO building.
