BIENNIAL REPORT ON AMERICANS WITH DISABILITIES ACT PUBLIC SERVICES AND ACCOMMODATIONS INSPECTIONS

ACCESSIBILITY REPORT
116TH CONGRESS

OFFICE OF CONGRESSIONAL WORKPLACE RIGHTS

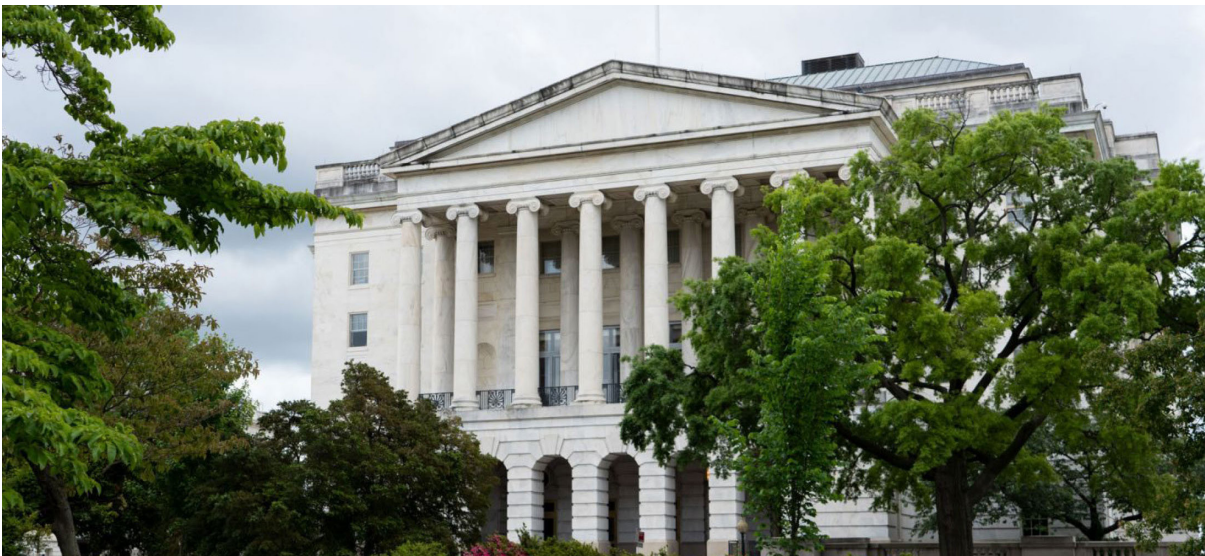
The chart that follows lists the total number of barriers in each category we identified in Member offices in Longworth and describes the specific types of barriers within each category.

In Longworth, we found 17 barriers in Member offices. Barriers were identified in the categories Interior Route, Doors, and Storage.

Two of the barriers identified in Longworth are whole facility barriers. The first is in the Doors category. Many office reception areas had desks or other nonpermanent obstructions blocking a doorway's required maneuvering clearance, making those doors difficult to open from a wheelchair. This issue could be addressed by rearranging furniture in these offices.

The second whole facility barrier in Longworth is in the Storage category. The barrier concerned office literature and magazine racks that were positioned outside of the required reach range, such that someone in a wheelchair or other mobility device may not be able to reach them.

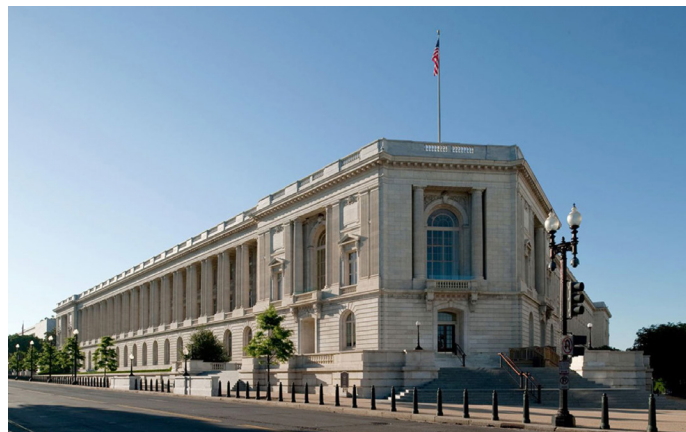
The chart that follows lists the total number of barriers in each category we identified in Member offices in Cannon and describes the specific types of barriers within each category.

In Cannon, we found 5 barriers in Member offices. Barriers were identified in the categories Interior Route and Storage.

The Storage category barrier was a whole facility barrier, present in many offices throughout Cannon. The barrier concerned office literature and magazine racks that were positioned outside of the required reach range, such that someone in a wheelchair or other mobility device may not be able to reach them.

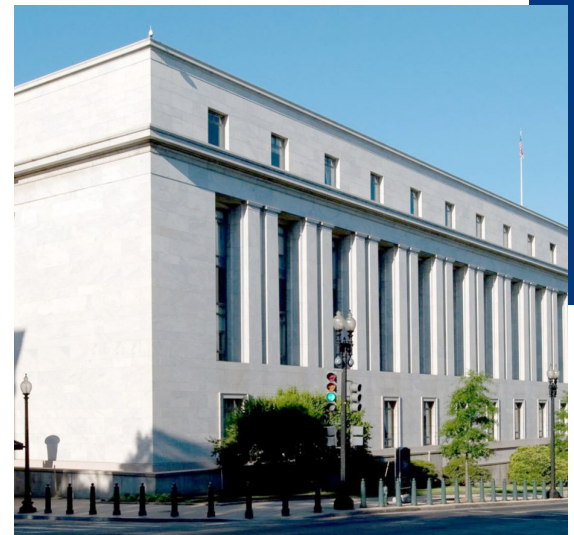
The chart that follows lists the total number of barriers in each category we identified in Ford and describes the specific types of barriers within each category.

We found 13 barriers in Ford’s health unit. Seven were identified in the single-user restroom, including grab bars located in incorrect positions. Throughout this health unit, door hardware requires tight grasping and twisting to operate.

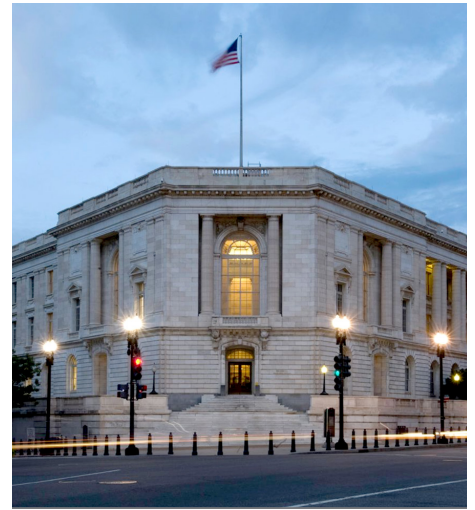
The chart that follows lists the total number of barriers in each category we identified in Russell's health unit and describes the specific types of barriers within each category.

Three barriers were found in the health unit in the Russell Office Building: two related to doors, and one related to the restroom.

Our barrier survey format lists one barrier in the restroom. In fact, the barrier notes clarify that this restroom does not provide any accessibility features, including clear floor space for someone using a mobility device, grab bars, and dispensers within required reach ranges.
